Gateway International Bridge Annual Inspection Report

GATEWAY INTERNATIONAL BRIDGE ANNUAL INSPECTION REPORT

SUBMITTED TO:
CAMERON COUNTY
BROWNSVILLE, TEXAS

FEBRUARY 25, 2013

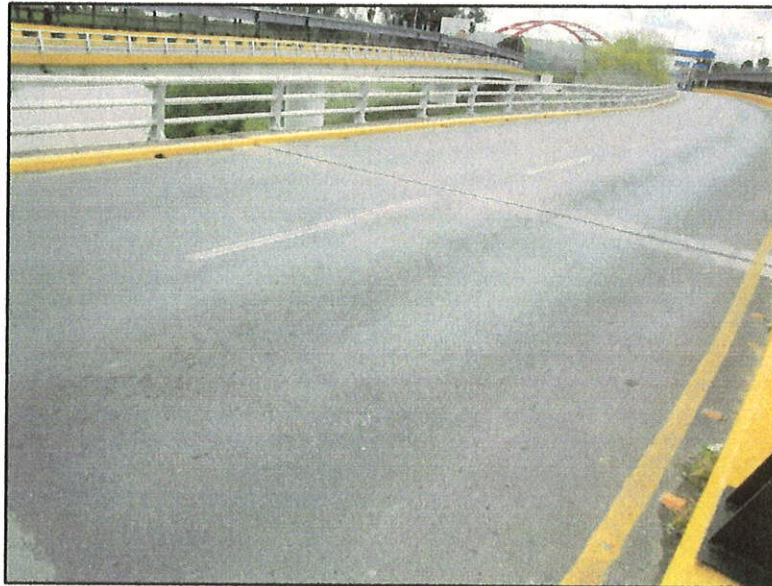
Figure 3.1.1–A (Mexico)

There are minimal visible cracks worth noting, the wear of the deck surface is average, and overall the deck appears to be in good condition. The asphalt overlay appears to be structurally adequate and the lane stripes are consistent and visible throughout the bridge. Figure 3.1.1–A shows an overall view of the deck while Figure 3.1.1–B shows the extent of transverse cracking found in the deck. These cracks are located on span 7 near the expansion joint at bent 8.

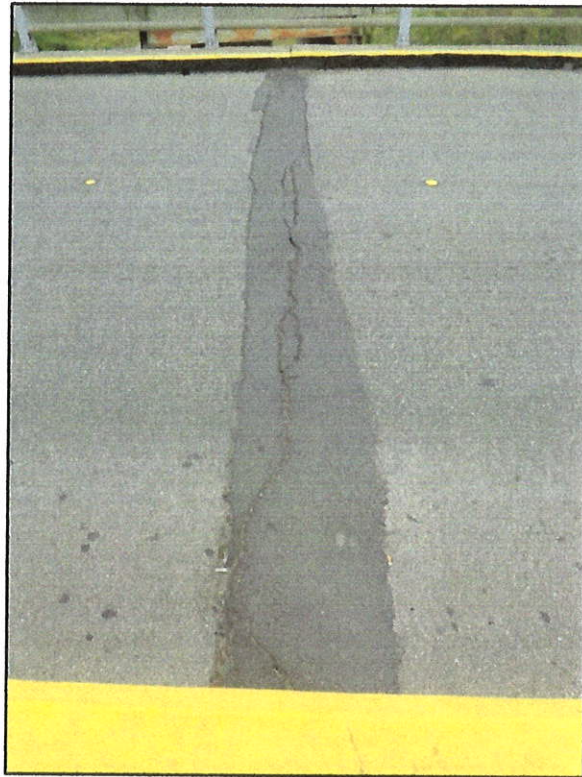
Figure 3.1.2–A (U.S.)

Expansion joints were only visible along the width of the roadway since the concrete curb and sidewalk covered them along the edges of the bridge. We are not able to inspect the expansion joints at abutment 7 and bent 8 since they are covered with asphalt overlay. The asphalt overlay at these joints restricts bridge movement which adds additional loading to the other bridge elements, thus potentially reducing their structural life. As for the remaining expansion joints, they are filled with debris; nonetheless appear to be in good condition. All joints are properly aligned and appear to be structurally adequate. Although there is notable damage to the curb and sidewalk at the expansion joint ends there is no visible damage to the joint alignments. Figure 3.1.2-A shows an example of an asphalt covered expansion joint. Figure 3.1.2-B shows a typical uncovered expansion joint. Figure 3.1.2-C shows end of expansion joint at damaged edge of sidewalk.

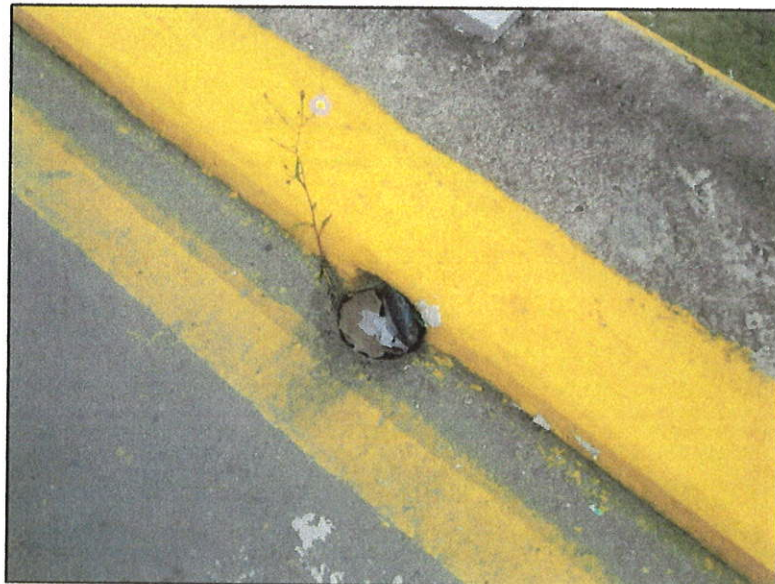
Figure 3.1.3–A (Mexico)

The bridge drains are located alongside the curb at the east edge of the bridge roadway. There is various debris and vegetation present in the drains throughout the bridge. Overall they need to be cleaned but are in satisfactory condition. Figure 3.1.3–A shows an example of a drain that warrants cleaning and maintenance.

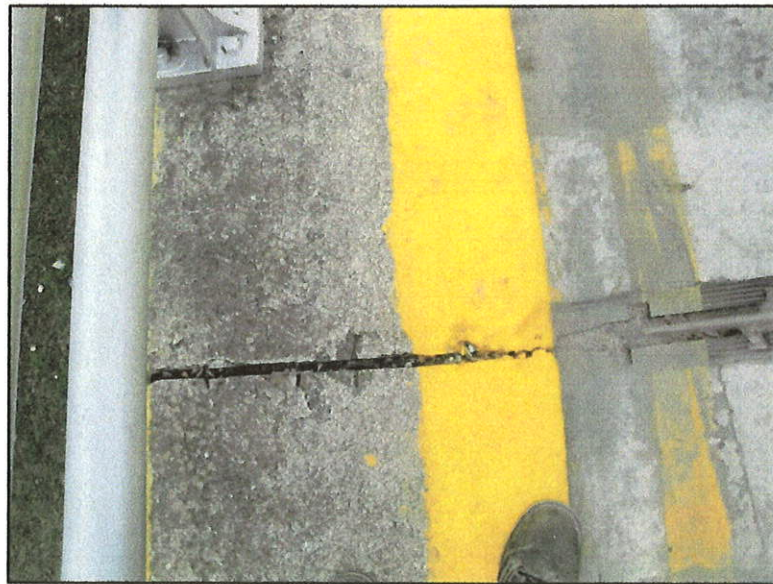
Figure 3.1.4–A (Mexico)

A concrete curb runs along the east edge of the bridge roadway and a concrete sidewalk runs along the west edge. The curb has minor cracking and spalling at the expansion joint locations. There is also moderate spalling and rebar exposure on top of the curb surface. Concrete spalling is also notable along both edges of the curb. See Figure 3.1.4–A thru C for examples of notable curb damage. The top and edge of sidewalk also has cracking and spalling at the expansion joint locations. The top of the sidewalk has consistent transverse cracking and missing tiles throughout the bridge. There are various areas where the edge of the sidewalk has moderate longitudinal and transverse cracking. Figure 3.1.4–D thru F show examples of sidewalk damage. Overall the curb and sidewalk appear to be in satisfactory condition but will require maintenance in the near future.

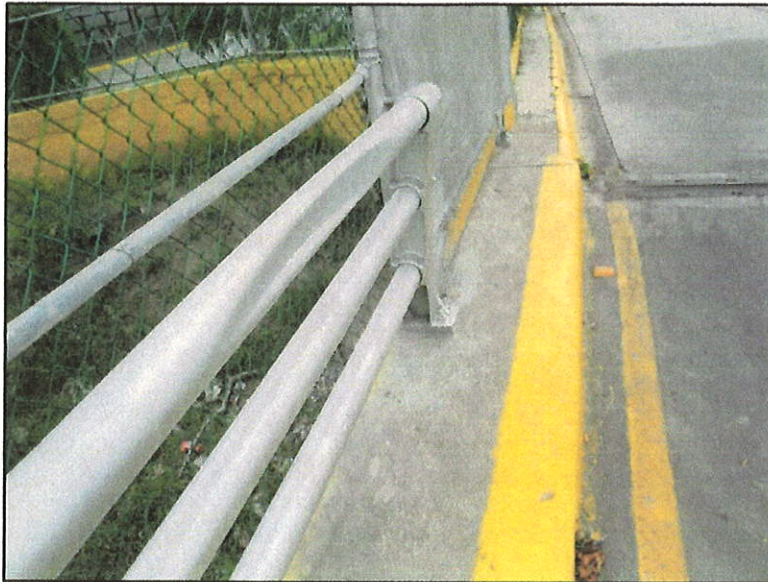
Figure 3.1.5–A (Mexico)

The traffic rail that runs along the east edge of the roadway has minimal damage and constructability issues. There is a dent at the top of the rail near abutment 13 possibly caused by vehicle impact (See Figure 3.1.5–A). There is only one area where the rail is misaligned; however, the rail is still functional at this location (See Figure 3.1.5–B). There are various locations where the anchor bolt nuts are not properly tightened to the top of the rail connection plate. Figure 3.1.5–C illustrates an example of this. There is spalling present at the top of the curb where the rail is bolted in (See Figure 3.1.5–D for visual). Overall this traffic rail appears to be structurally adequate and in satisfactory condition.

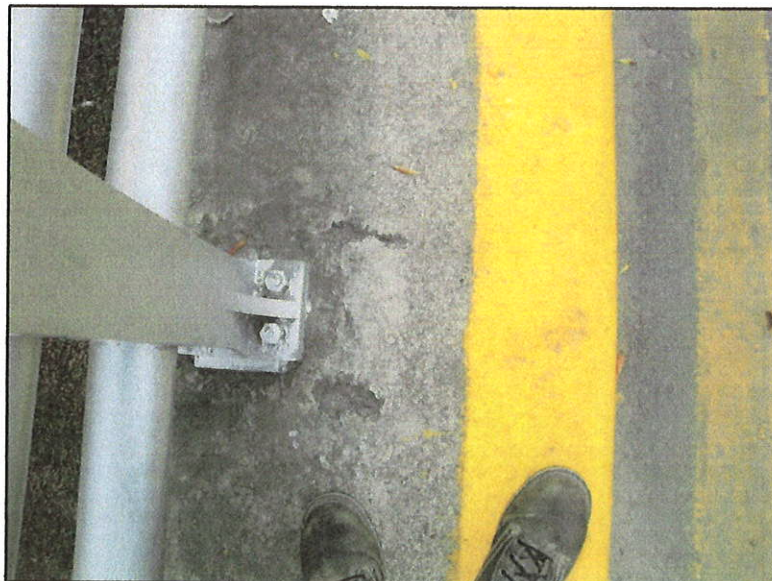
Figure 3.1.5–D (Mexico)

The pedestrian combination rail (PCR) that runs along the west edge of the roadway has minor honeycombing and transverse cracking throughout. The alignment of PCR is good and no major damage was noted. There is one post connection that does not have any bolts attached located at abutment 13. All other post connections at the top of the rail are satisfactory along with the paint of both the concrete and steel. Figure 3.1.5–E shows an unbolted post connection. Figure 3.1.5–F shows typical PCR honeycombing while Figure 3.1.5–G shows typical transverse cracks on the top of rail. Overall the PCR appears to be in satisfactory condition. Other than the bolts needed for the post connection at abutment 13 there is minimal maintenance needed for this rail.

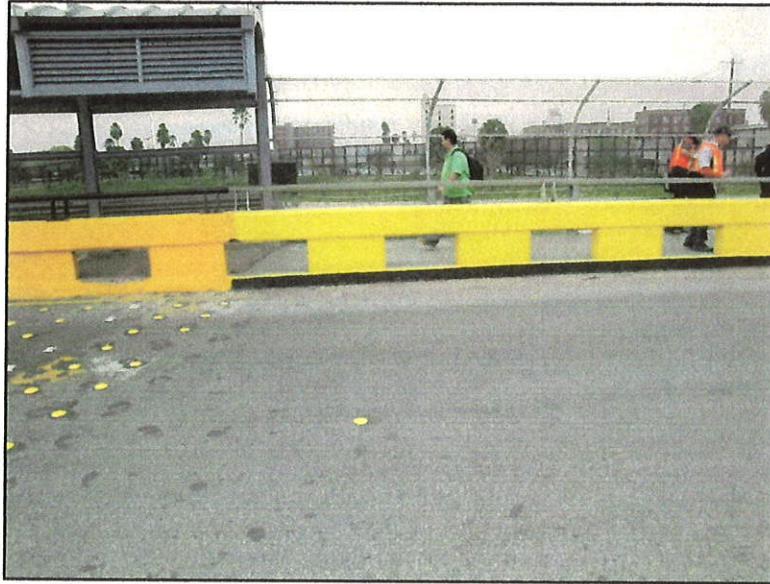
Figure 3.1.6—A (Mexico/U.S.)

The canopy (Mexico side) and high fence (U.S. side) both appear to be structurally adequate. Amongst the damage noted include missing bottom panels, damaged bottom panels, loose wiring, and concrete spalling around the bolted connections to the sidewalk. There are also areas where the fencing panels are loose or not re-attached properly. The traffic rail behind the canopy and high fence is in very good condition since it has minimal exposure to pedestrians and traffic. There is no notable damage to high fence on the U.S. side of the bridge. Figure 3.1.6–A shows the canopy on the left and the high fence on the right. This marks the border line for the U.S. and Mexico. Figure 3.1.6–B illustrates both a missing panel from the canopy and the traffic rail sitting behind it. Figure 3.1.6–C shows a piece of the canopy fencing that needs to be re-attached properly. Overall the canopy and high fence appear to be in good condition.

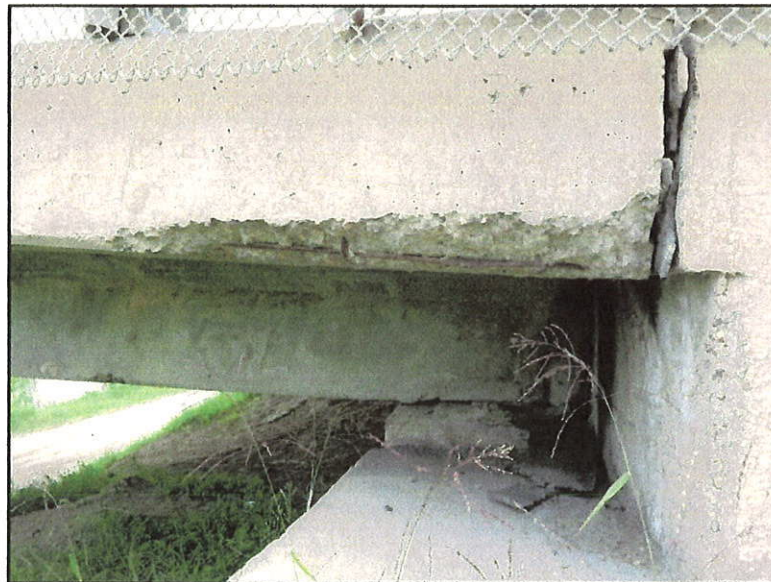
Figure 3.2.1-A (U.S.)

Figures 3.2.1-A and 3.2.1-B show a couple of locations at span 7 near abutment 7 where the overhang concrete is spalled off and has exposed rebar. These two areas of spalled concrete and exposed rebar are two of the most severe examples of this type of deterioration on the concrete overhangs. Similar areas with spalled concrete and exposed rebar exist in other areas of the slab and overhangs, but, most are not to the degree depicted in these two figures. On the overhangs it appears that most of the exposed rebar is in the narrow cast-in-place concrete on the edges of the overhangs. The condition of spalled concrete and exposed rebar, although it appears extensive in that it occurs in many areas throughout the bridge, is considered minor deterioration at this time and does not significantly affect the structural capacity of the bridge.

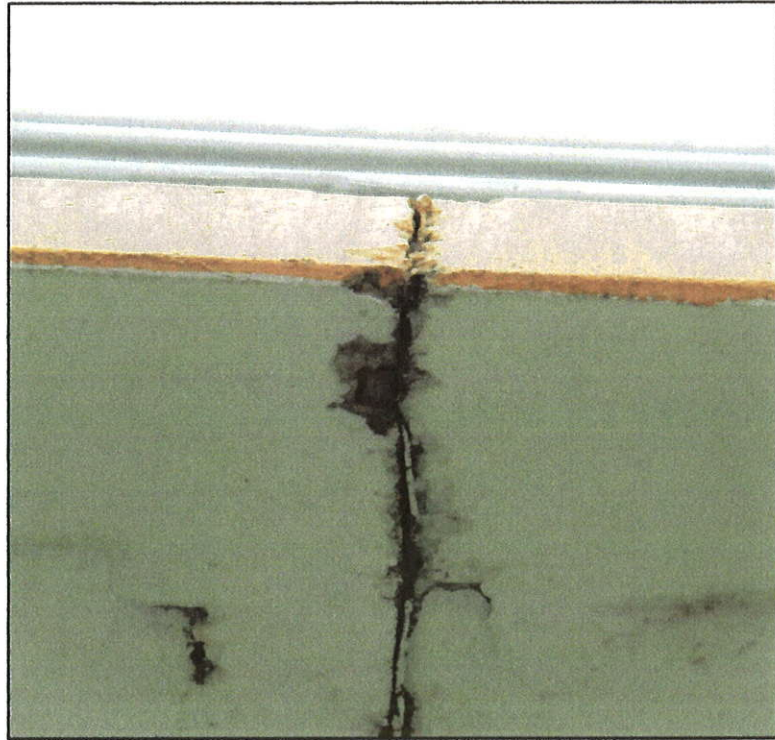
Figure 3.2.1-C (Mexico)

The joints between concrete slab units and the concrete bent caps were rough in some locations. Figure 3.2.1-C illustrates one such joint as viewed from the overhang soffit. Also shown is some concrete spalling and exposed rebar along and near the joint on the overhang.

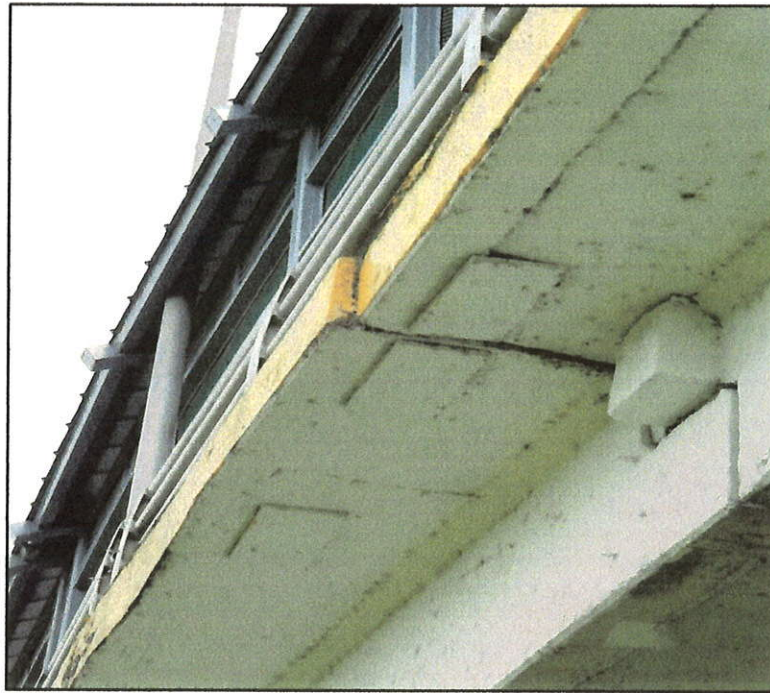
Figure 3.2.1-D (Mexico)

At span 10, on the upstream side of the slab and at the joint with bent cap 10, the edge of the slab overhang and bent cap overhang are offset. The edge of the exterior beam below this area of the overhang appears to be in line with the adjacent edge of the bent cap, or only slightly offset. This offset may be due to slight differential displacement or movement between the slab and the bent cap or due to misalignment of the edge of the overhang on the bent cap during construction. Figure 3.2.1-D shows a close up of this condition. It appears that this condition does not significantly affect the structural capacity of the bridge at this time, but warrants close monitoring.

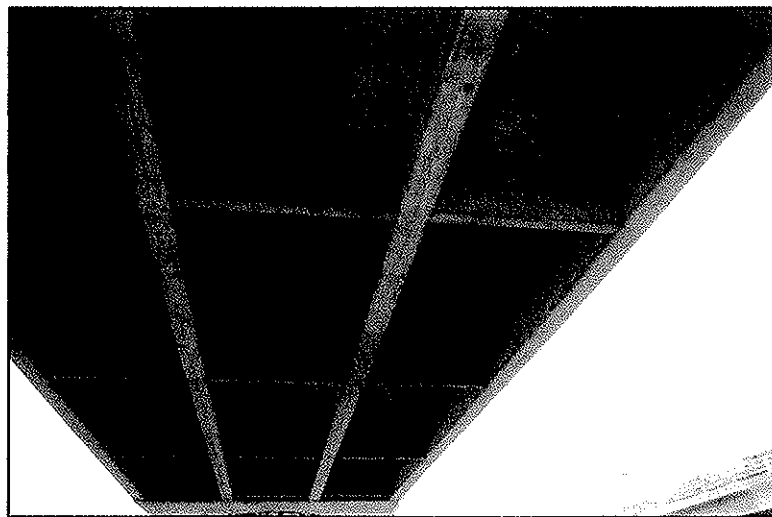
Figure 3.2.2-A (Mexico)

The bridge spans consist of a slab span with exterior beams in span 7 and T-beam spans from span 8 through span 12. On the Mexican side of the bridge the bottoms of the beams have many small patches in spans 10 through 12 where it appears that exposed rebar or other deterioration may have been patched and repaired. Some exposed rebar was seen at the bottom of some of the beams on span 9 as shown by the small dark spots at the bottom of the second beam from the left in Figure 3.2.2-A. The exposed rebar is minor deterioration and does not significantly affect the structural capacity of the bridge. Observation of the bearing pads and bearing seat areas was limited to the abutments where observation was still limited due to the confined space. However, observation of the bearing areas did not reveal any problems with the beams. Overall the beams appear to be in good structural condition.

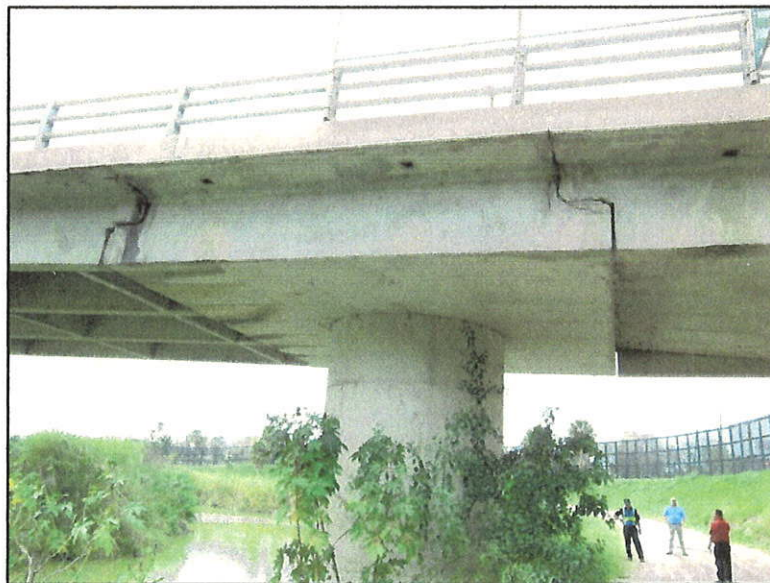
Figure 3.3.1-A (U.S.)

Observation of the bearing seats and bearing pads was limited to the abutments since no overhead equipment was provided. The bearing pads at abutment 13 appear to be slightly bulging. The abutment 13 cap bearing seat areas have dirt and small pieces of rubble. At bent cap 8 on the downstream edge of the bearing section supporting the exterior beam of span 7 there is some cracking of the bent cap as shown in Figure 3.3.1-A. The concrete at this bearing seat is significantly cracked. There is also exposed rebar in this bearing area. This area of this bent cap is in fair to poor condition and is in need of repair. The bearing seats and bearing pads in all other areas are considered to be in satisfactory condition.

At bent cap 8 on the downstream edge of the bearing section supporting the exterior beam of span 7 there is some cracking of the bent cap as shown in Figure 3.3.1-A. This area of bent cap 8 is in need of repair. In the same figure, but on the opposite end of the cap, the bottom of the cap is stained. Stains were present to varying degrees on other bent caps as well. On the bottom of the bent 8 cap minor cracks and exposed rebar and honeycombing were observed in some locations. Bent cap 12 has evidence of epoxy injection repair work. Figure 3.3.2-A shows some spalling at the corner and edge of one of the bent caps on the Mexican side of the bridge. Except for the area of bent cap 8 that needs repair mentioned above, the bent caps are generally in satisfactory to good structural condition.

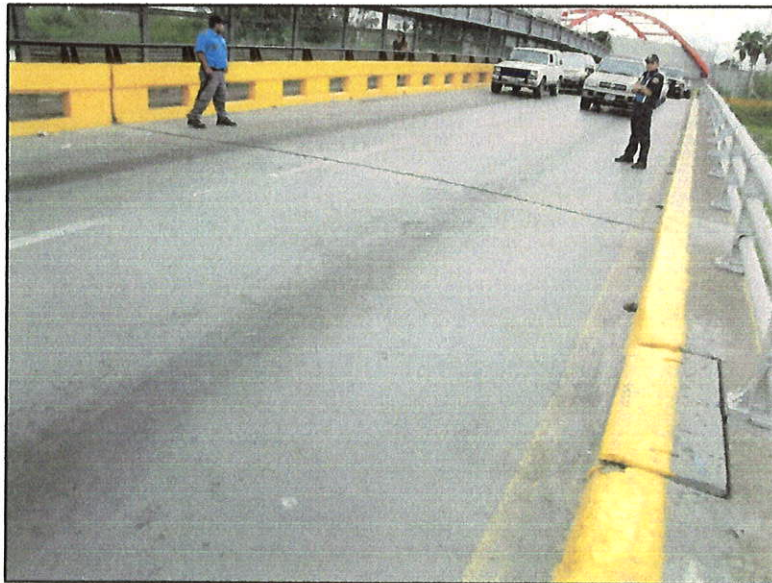
Figure 4.1.1–A (Mexico)

There are visible cracks at the joint locations in the asphalt overlay. The wear of the deck surface appears to be considerable. There are numerous ruts located near the bridge joints throughout the bridge. Also, the lane stripes are intermittent and lack consistency throughout the bridge. Nonetheless, the asphalt overlay still appears to be structurally adequate and in satisfactory condition. Figure 4.1.1–A shows an overall view of the deck while Figure 4.1.1–B shows the asphalt cracking found at the joint locations. Figure 4.1.1–C illustrates examples of the ruts in the asphalt.

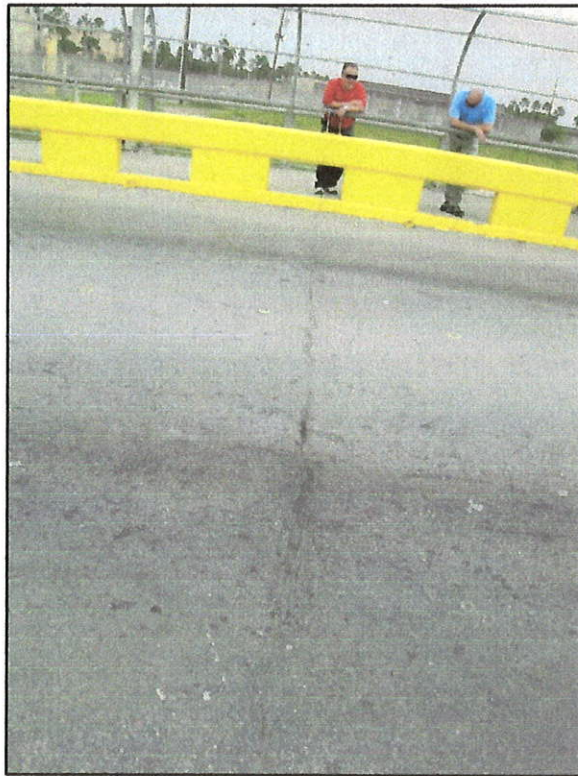
Figure 4.1.2-A (U.S.)

Expansion joints are only visible along the width of the roadway since the concrete curb and sidewalk cover them along the edges of the bridge. We are not able to inspect the expansion joints at bent 5 and abutment 6 (U.S. side of bridge) since they are covered with asphalt overlay. There are transverse cracks in the asphalt overlay covering these joints. The expansion joint at abutment 6

is slightly visible due to the wearing of the deck at this location. The asphalt overlay at these joints restricts bridge movement which adds additional loading to the other bridge elements, thus potentially reducing their structural life. As for the remaining expansion joints, they are filled with debris and trash; nonetheless are in good condition. All joints are properly aligned and do not show any major signs of damage. Although there is notable spalling and cracking on the curb and sidewalk at the expansion joint ends the negative effects on the joint alignments is minimal. Figure 4.1.2-A shows an example of an asphalt covered expansion joint at Bent 5. Figure 4.1.2-B shows a typical uncovered expansion joint. Figure 4.1.2-C shows the damaged end of the expansion joint at bent 4.

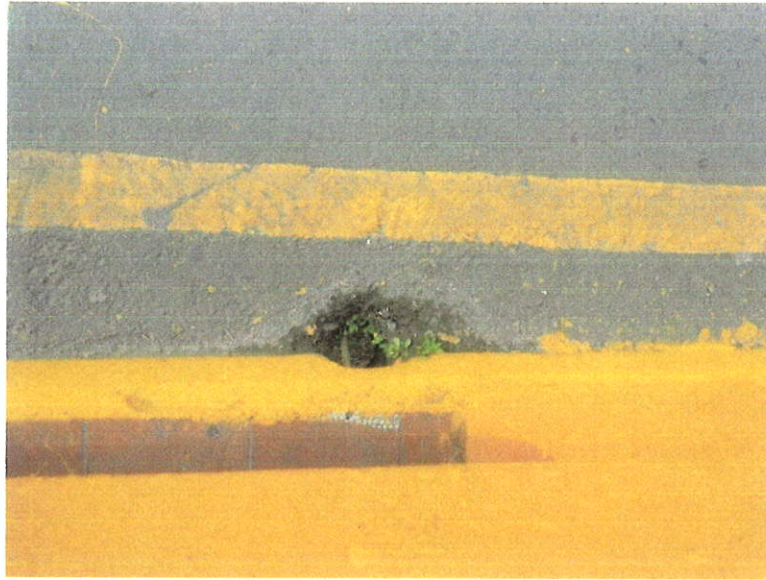
Figure 4.1.3–A (Mexico)

The bridge drains are located alongside both the curb at the west edge of the bridge roadway and the sidewalk along the east edge of the roadway. There is various debris and vegetation present in the drains throughout the bridge. Overall they need to be cleaned but are in satisfactory condition. Figure 4.1.3–A shows an example of a drain that warrants cleaning and maintenance.

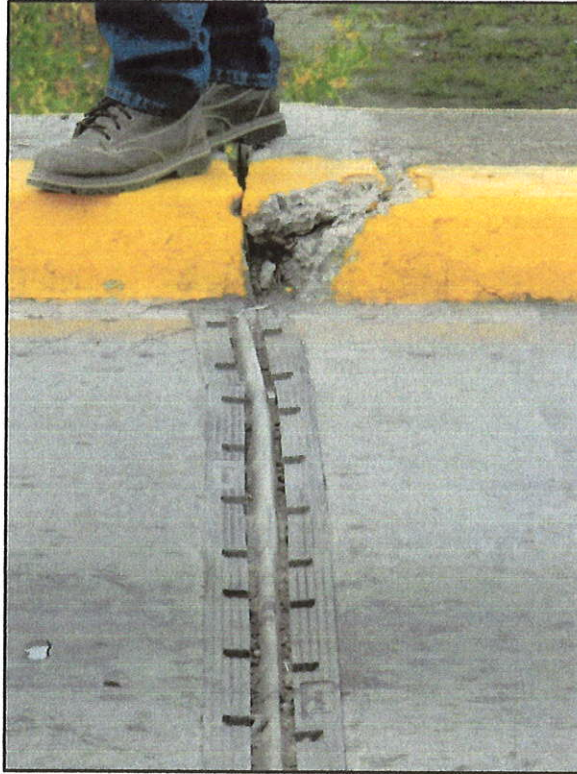
Figure 4.1.4–A (Mexico)

A concrete curb runs along the west edge of the bridge roadway and a concrete sidewalk runs along the east edge. The curb has minor to moderate cracking and spalling at the expansion joint locations. There is also minor to moderate spalling and rebar exposure on top of the curb at various locations throughout the bridge. There is a curb cut out located above bent 4 (unsure of its intended purpose) that has moderate spalling and rebar exposure. Concrete spalling is also notable along the inside edge of the curb. See Figure 4.1.4–A and B for examples of notable curb damage. Figure 4.1.4–C shows the curb cut out. The top and edge of sidewalk also has cracking and spalling at the expansion joint locations. The top of the sidewalk has consistent spalling and transverse cracking throughout the bridge. Because of the excessive wear to the top of the sidewalk the surface is not smooth and noticeably uneven. There are various areas where the edge of the sidewalk has minor longitudinal and transverse cracking. Figure 4.1.4–D and E show the excessive wear to the top of the sidewalk (U.S. side of bridge). Figure 4.1.4–F shows edge of sidewalk cracks.
